# N7484Q

## Pre-Purchase Squawk List

**Prepared by**  
Owen Poirier

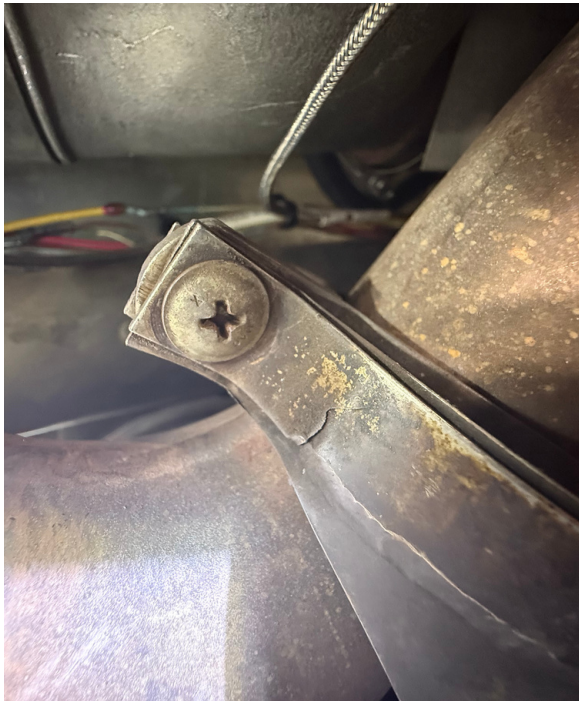
Item #1

| Squawks | | | | |
|---|---|---|---|---|
| 1 | Small crack noted on carburetor heat intake attaching clamp | O-470 MM | Spot weld small crack or replace clamp | UNK |

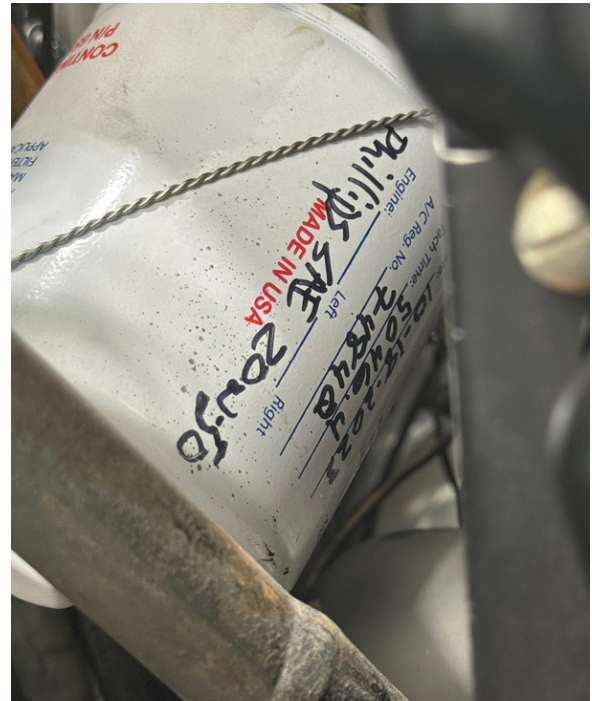
Item #2

| Squawks | | | | |
|---|---|---|---|---|
| 2 | Oil filter dated 2023 (AIRWORTHINESS) | O-470 MM | Recommended oil life is 6 months or 50hrs. Perform oil change as required | \$250 |

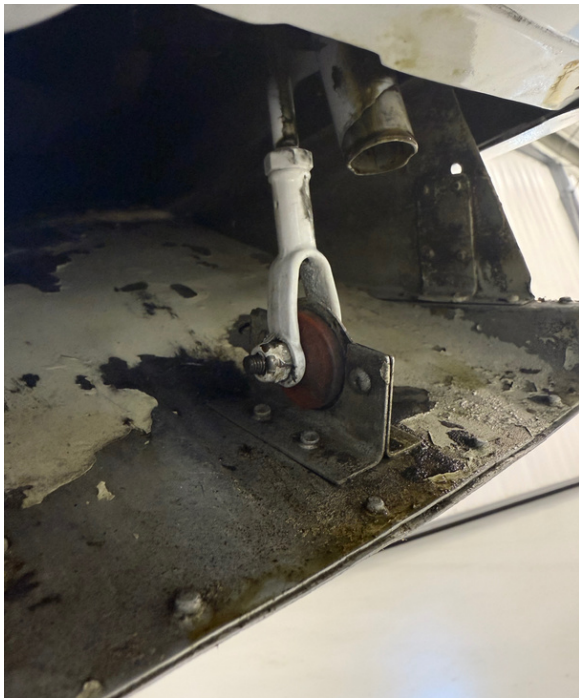
Item #4

| Squawks | | | | |
|---|---|---|---|---|
| 4 | RH cowl flap attaching bracket has oblong/oversized hole. LH cowl flap cable chafed through (AIRWORTHINESS ITME) | C-182P MM | Remove and replace cowl flap attach bracket (P/N:0752623-1)<br>Remove and replaced LH cowl flap cable (P/N:MC9860058-3) | \$1300 |

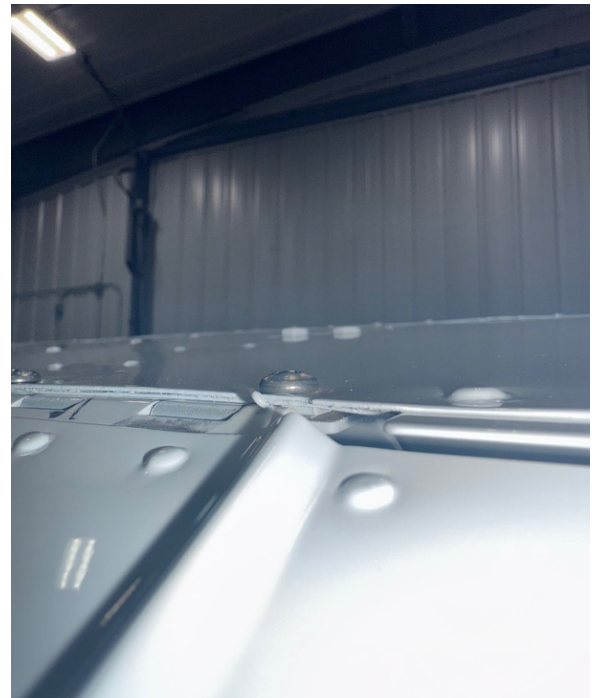
Item #5

| Squawks | | | | |
|---|---|---|---|---|
| 5 | Ailerons installed improperly (AIRWORTHINESS ITEM) | C-182P MM | Remove ailerons, reinstall in-between wing skin as mentioned in par 6-16 of the 182P MM | \$250 |

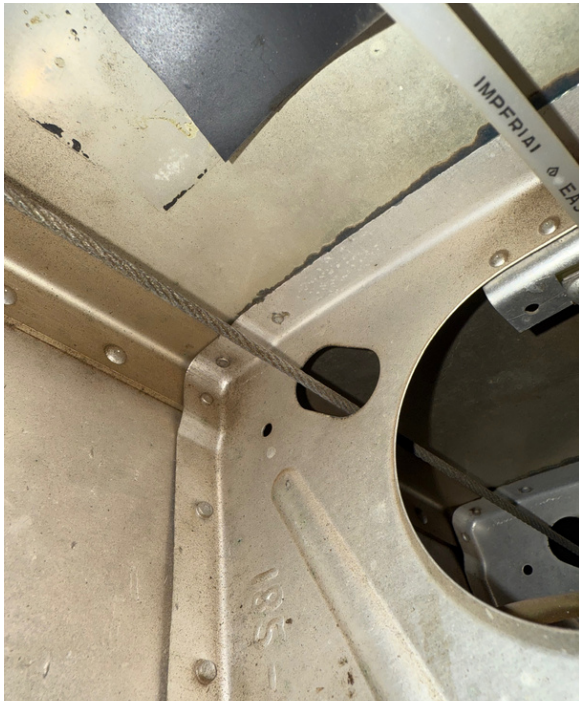
**Item #6**

| Item | Description | Reference | Recommendations | Estimated Correction Cost |
|---|---|---|---|---|
| 6 | LH forward aileron cable tension low. Cable striking forward ribs when aileron is moved (AIRWORTHINESS ITEM) | C-182P MM | Verify proper aileron cable tension and rigging | \$350 |

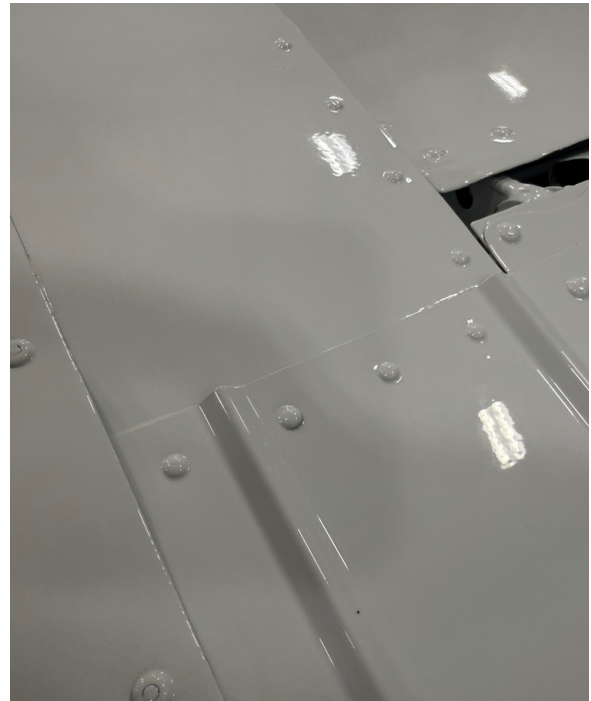
**Item #7**

| Item | Description | Reference | Recommendations | Estimated Correction Cost |
|---|---|---|---|---|
| 7 | Cessna SEB03-1 "Elevator Counter Weight" not complied with | SEB95-3 | Comply with SB by installation of rivets | \$500 |

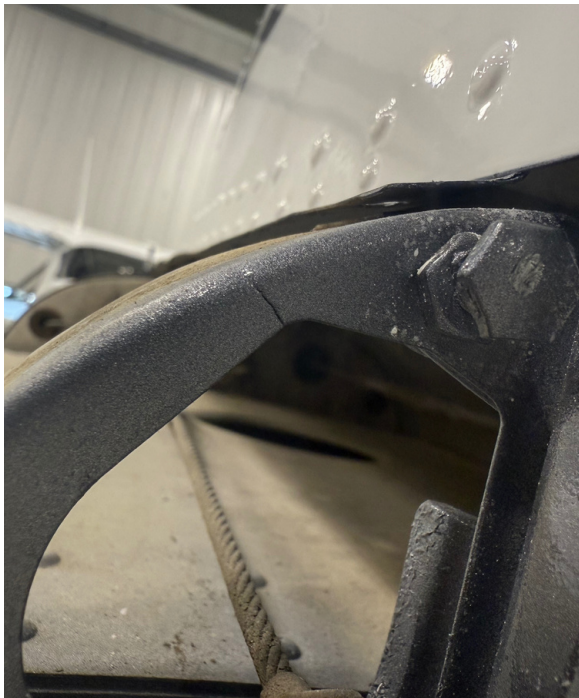
**Item #8**

| Item | Description | Reference | Recommendations | Estimated Correction Cost |
|---|---|---|---|---|
| 8 | Aft station 230 bulkhead cracked at upper LH corner. Fails AD72-07-09 (AIRWORTHINESS ITEM) | C-182P MM | Comply with Cessna SB 99-12 by installation of upgraded aft tail bulkhead (P/N:SK210-161-1) | \$10-\$13K |

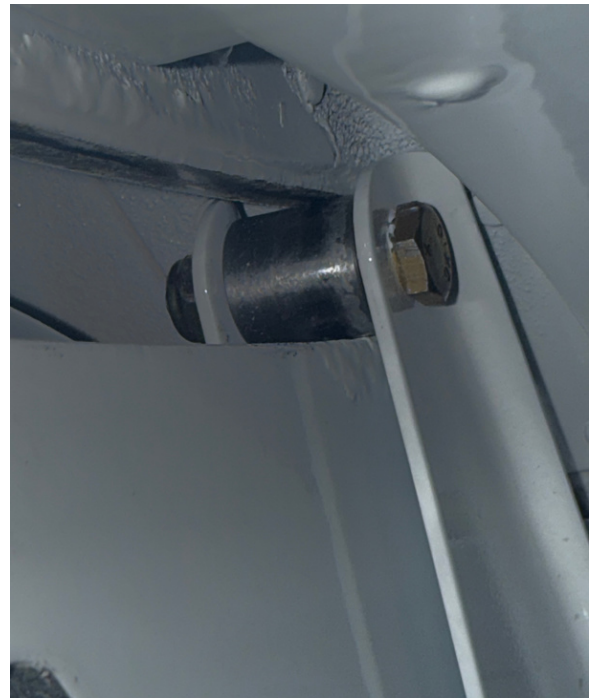
**Item #9**

| Item | Description | Reference | Recommendations | Estimated Correction Cost |
|---|---|---|---|---|
| 9 | Cessna SEB95-3 R1 "Flap roller wear washer" not complied with | SEB95-3 R1 | Comply with SB by installation of upgraded flap roller kit (P/NFLP-KT-3U) | \$750 |

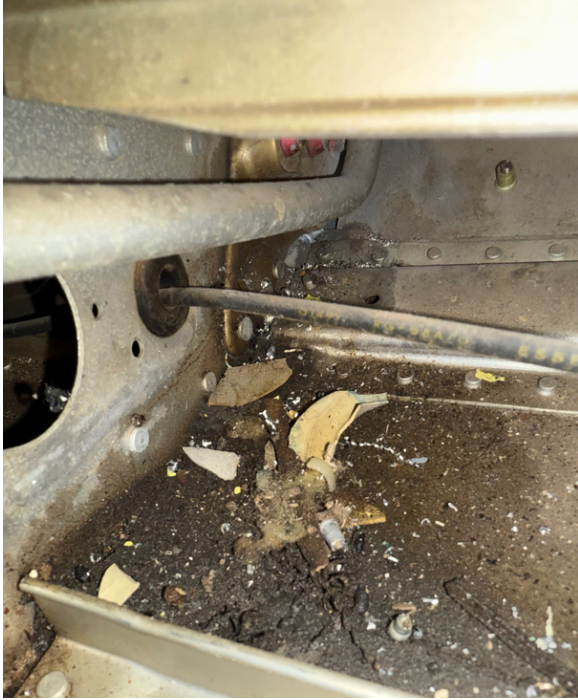
Item #10

| Item | Description | Reference | Recommendations | Estimated Correction Cost |
|---|---|---|---|---|
| 10 | Sheet metal debris, dirt/grease noted in subfloor. Inspection of strut to door post per AD very difficult | C-182P MM | Remove interior, wash and vacuum subfloor to remove FOD. Corrosion treat with ACF-50 | \$350 |

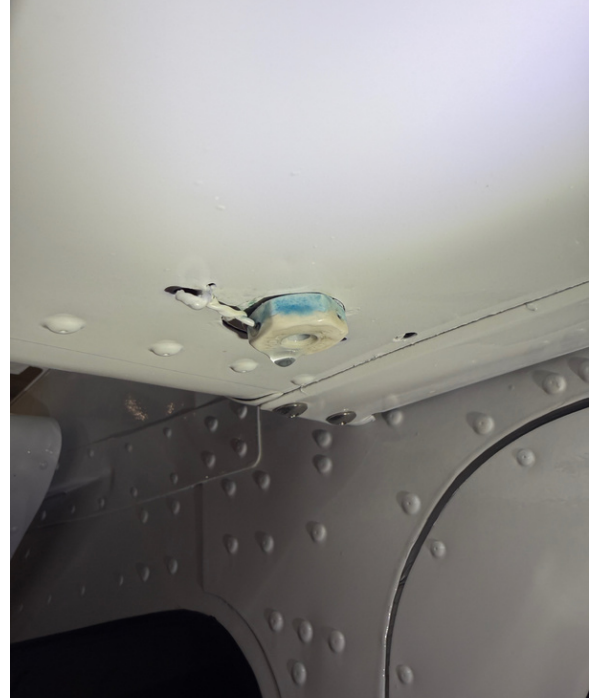
Item #11

| Item | Description | Reference | Recommendations | Estimated Correction Cost |
|---|---|---|---|---|
| 11 | RH fuel seeping | C-182P MM | Remove and replace fuel sump | \$50 |
